**PRITCHARD LIBRARY**

## **ABOUT OUR PROJECT**

## **BUILDING PROFILE**

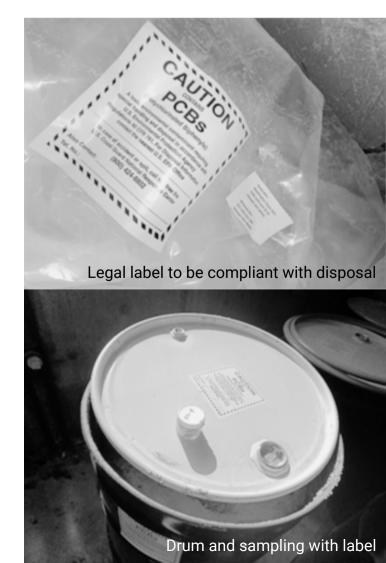
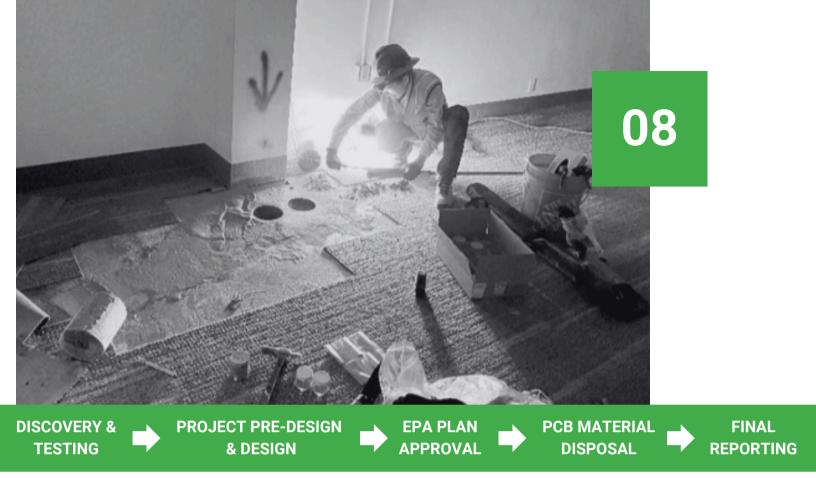
While desirable, the project team was unable to complete destructive sampling while the building was occupied due to the presence of public workers. The project team collected more than 25 samples from the expansion joints and cores in the concrete. The team conducted additional to determine whether PCBs sampling migrated into the substrate. Upon sampling the soil beneath the slab on grade, PCBs were detected. The initial sample collected from an expansion joint of 20 lineal feet contained more than 2 parts per million (ppm).

Preventing the spread of contamination required soft demolition via manual methods. Approximately 2,200 LF of expansion joint was removed by saw cutting.
